14. MONITORING AGENCY NAME & ADDRESS (If different from Controlling Office) (1) National Dam Safety Program. Turkey Creek Dams (MO 31101, MO 31108, MO 31109, MO 31602), Mississippi - Kaskaskia - St. Louis Basin, Wayne County, Missouri. Phase I Inspection Report.		12. REPORT DATE (11) August 1979

PHASE I INSPECTION REPORT
NATIONAL DAM SAFETY PROGRAM
TURKEY CREEK DAMS

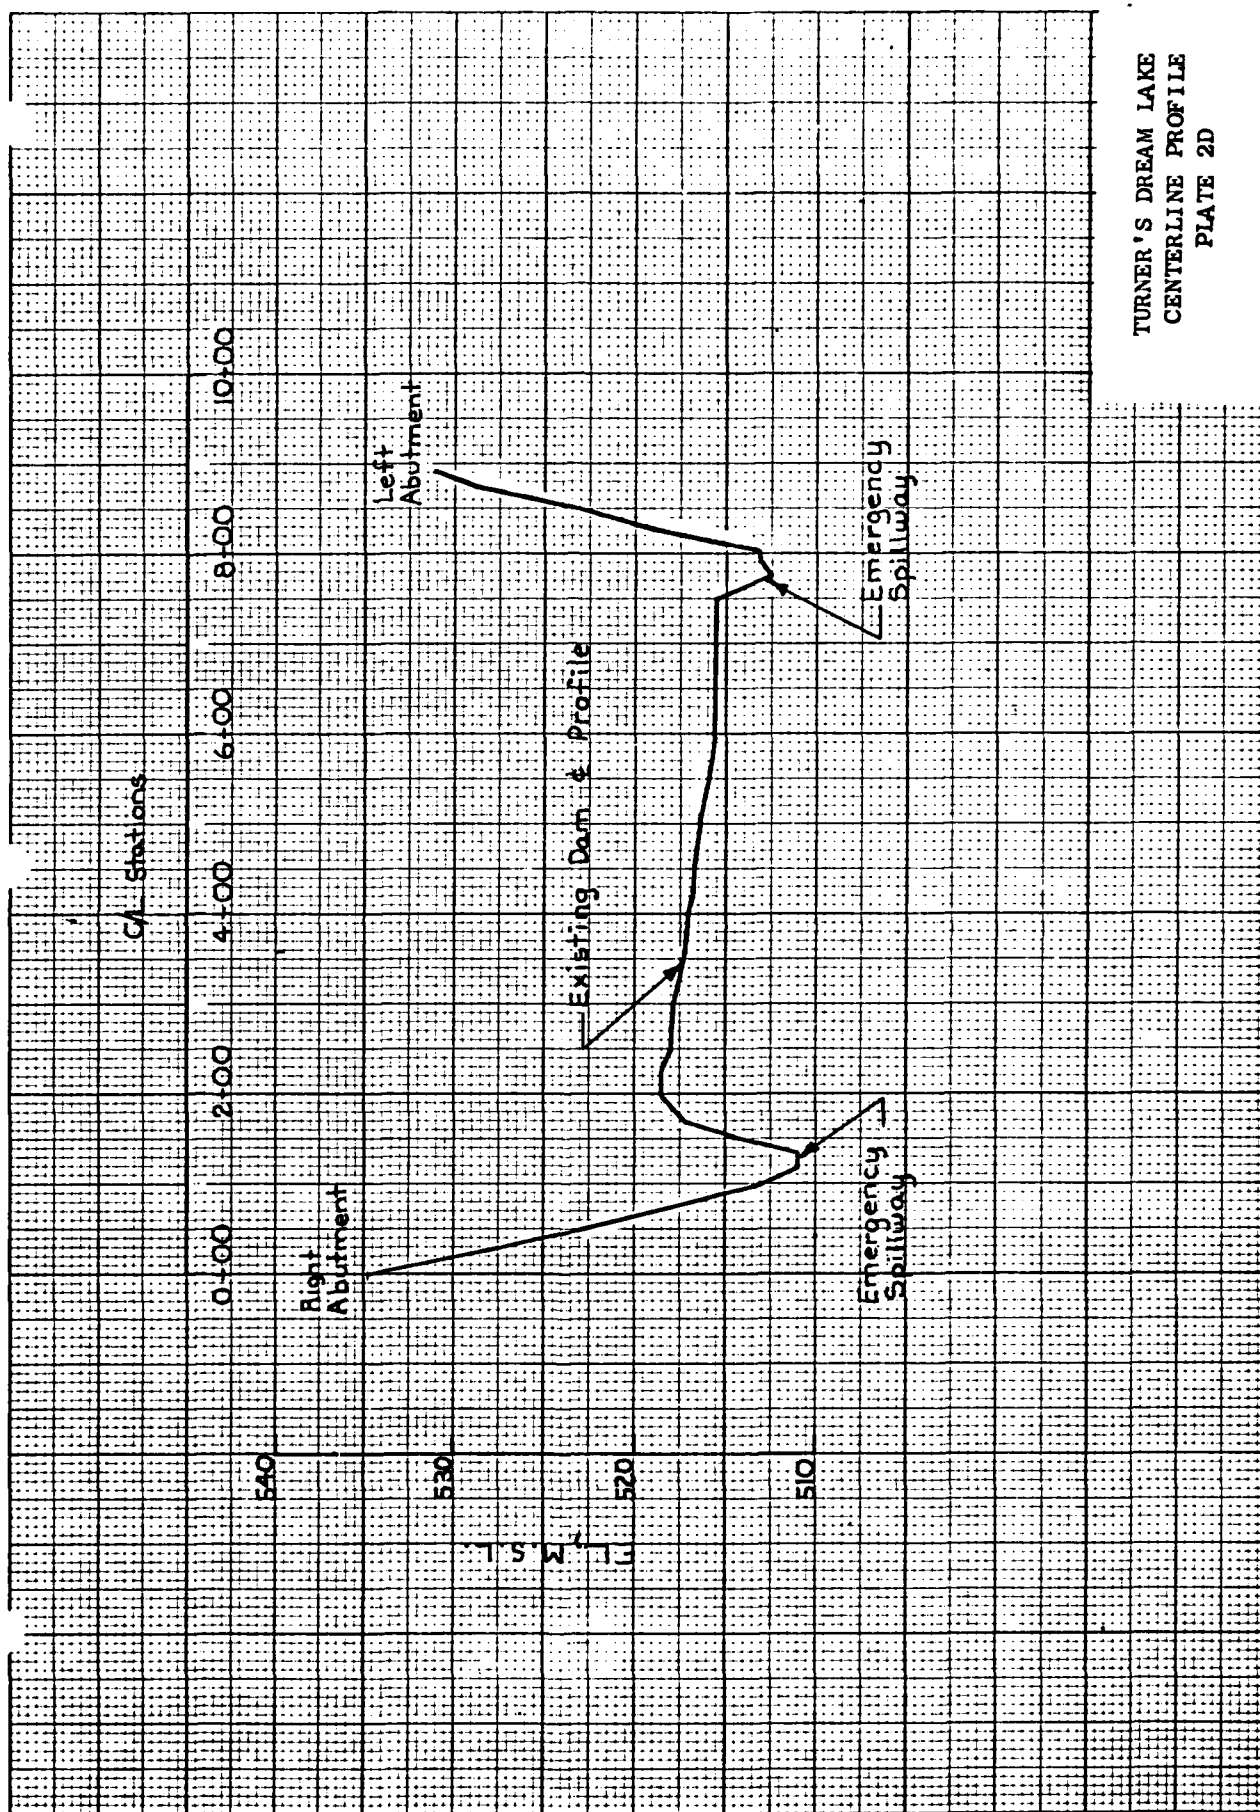
TURNER'S DREAM LAKE
CROSS-SECTION
EXISTING CONDITION
PLATE 3D

(1) Dam. No detrimental settlement, cracking, slides or animal burrows were observed in or near the earth embankment. Typical existing cross-sections of the embankment are shown on Plate 3D. The crown width was 20 feet. Based on the existing cross-section, the upstream embankment has an average slope of 1V on 2.9 H (See Plate 3D), and the downstream embankment has an average slope of 1V on 3.5 H (see Plate 3D and Photo 3D).
